Pilsen Old RV

Pilsen Soil Operable Unit 2 Residential

Photo Log

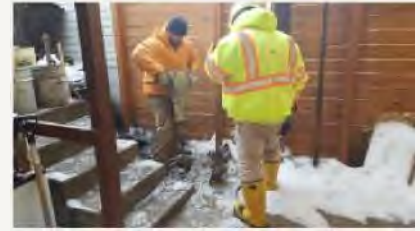
Description: EPA and START confirm depth of excavation is 1 foot bgs in the back yard soil area of the Non-Responsive Street property.

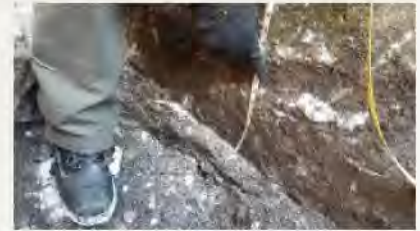
Description: Orange snow fencing placed in the bottom of the excavation in the back yard soil area of the Non-Responsive property.

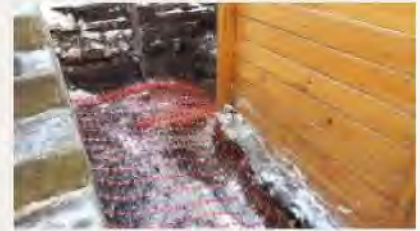
Description: The excavated back yard soil area of the Non-Responsive St property was backfilled with CA6 gravel by RP contractors as a 1-foot engineered barrier.

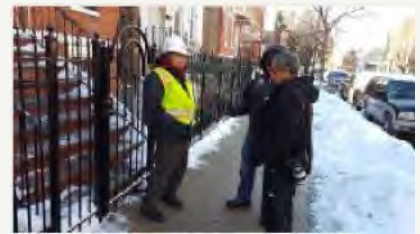
Description: EPA and START confirm depth of excavation is in the raised front yard garden area of the **Non-Responsive** property. Excavation depth was to the concrete pad at the bottom of the raised front yard garden area.

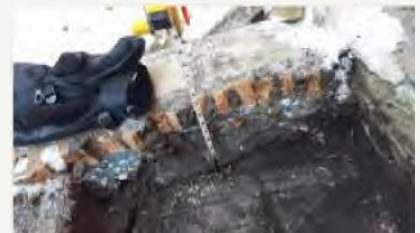
Description: The raised front yard garden area of the **Non-Responsive** property was backfilled with topsoil tested by the RP contractor and approved for use by EPA.

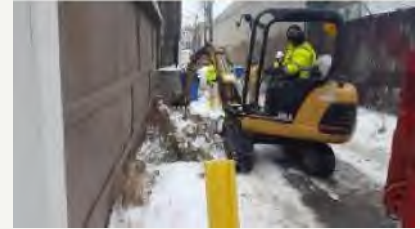
Description: EPA and START confirm depth of excavation is 1 foot bgs in the soil area behind the garage of the **Non-Responsive** property.

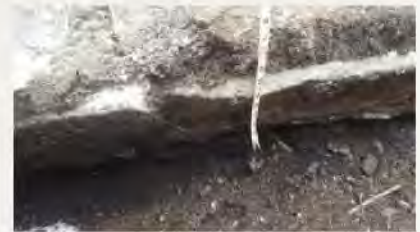
Description: Orange snow fencing placed in the bottom of the soil remaining in the excavation in the soil area behind the garage of the **Non-Responsive** property.

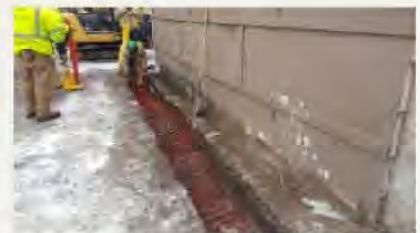
Description: The excavated soil area behind the garage of the **Non-Responsive** property was backfilled with CA6 gravel by RP contractors as a 1-foot engineered barrier.

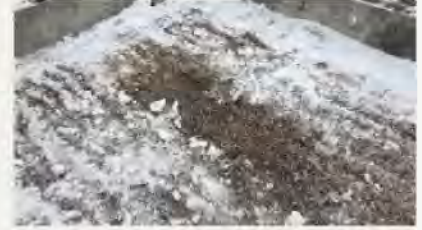
Description: RP contractors placing additional CA6 gravel in the gravel driveway area of the **Non-Responsive** property to add additional gravel cover to the shallow 3-inch gravel cover area.

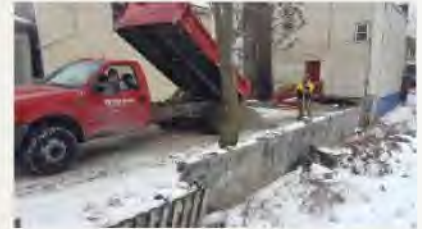
Description: RP contractors grading additional CA6 gravel placed in the gravel driveway area of the **Non-Responsive** property to add additional gravel cover to the shallow 3-inch gravel cover area.

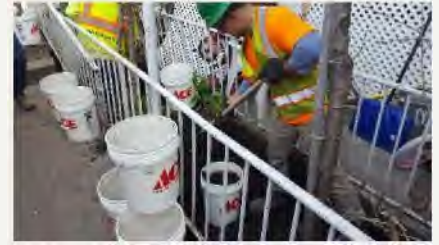
Description: RP contractors replacing soil in excavated back yard garden of **Non-Responsive**.

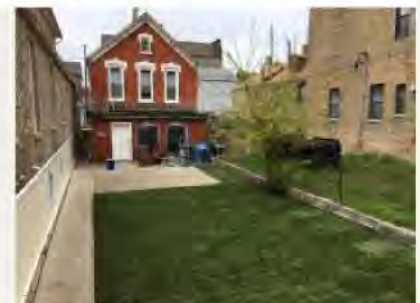
Description: RP contractors laying sod at **Non-Responsive**.

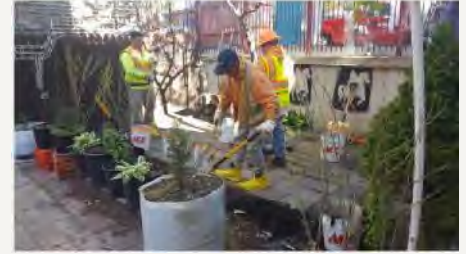
Description: RP contractors excavating soil from front yard soil strip of **Non-Responsive**.

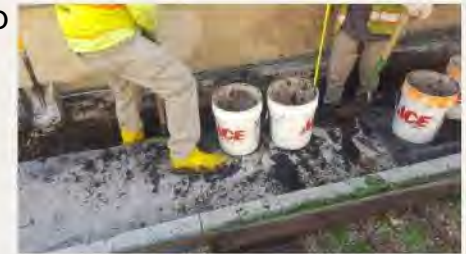
Description: Excavated front yard soil strip of **Non-Responsive**.

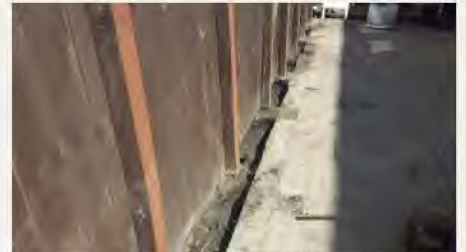
Description: Gravel backfilled and compacted in a former soil strip area of **Non-Responsive**.

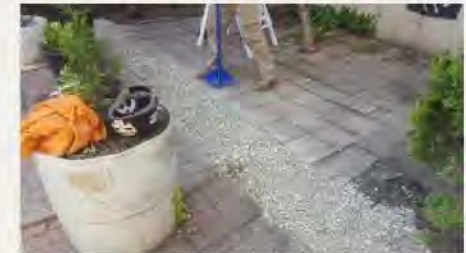
Description: Gravel backfilled and compacted in a former soil strip area of **Non-Responsive**.

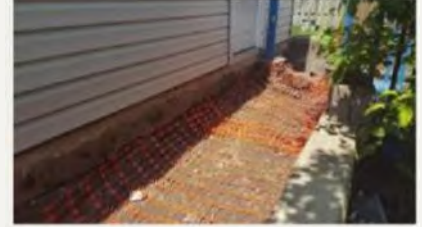
Description: View of completed restoration in the garden to the east of the retaining wall in the back yard of Non-Responsive looking southwest.

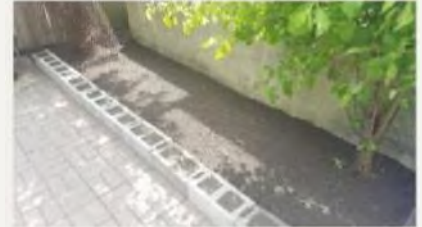
Description: View of completed backfill to the east of the garage at Non-Responsive looking north.

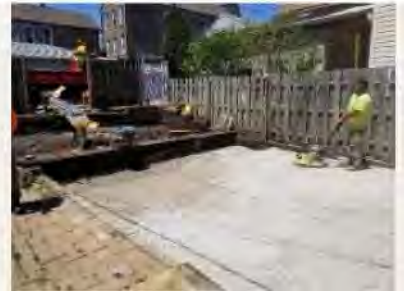
Description: Backfill operations on a sunken yard of **Non-Responsive** using conveyor belts.

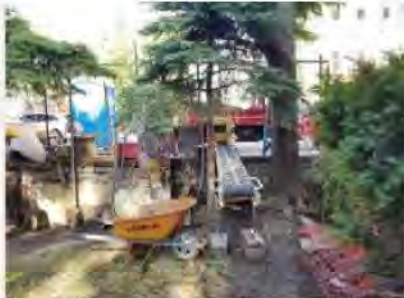
Description: RP contractors excavating in the back yard of **Non-Responsive** using shovels and a vac truck hose.

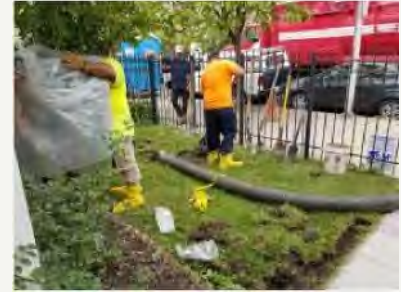
Description: View of the front yard excavation of [Non-Responsive] [Non-Responsive]

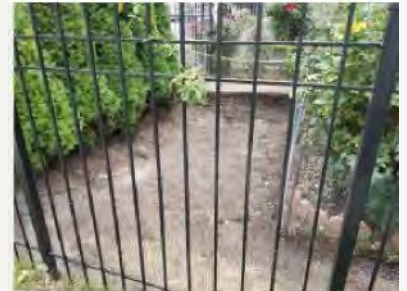
Description: RP contractors excavating the front yard of [Non-Responsive] [Non-Responsive].

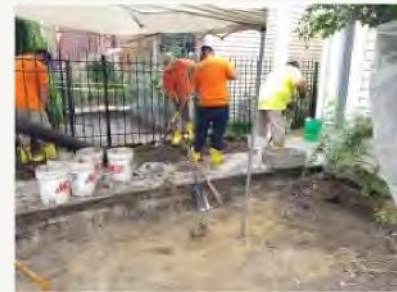
Description: RP contractors completing clean soil backfill in the back yard of [Non-Responsive] [Non-Responsive].

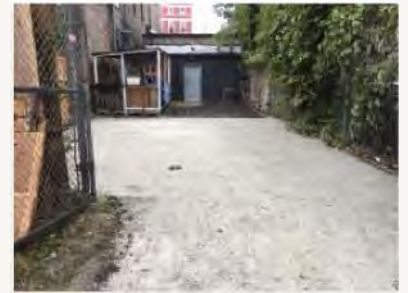
Description: RP Contractors compacting clean backfill at **Non-Responsive**.

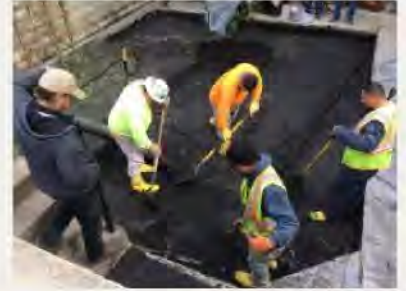
Description: RP contractors excavating the back yard of Non-Responsive.

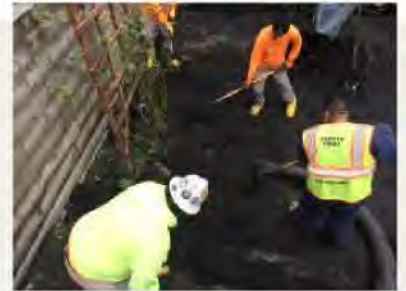
Description: Excavation progress in the back yard of Non-Responsive.

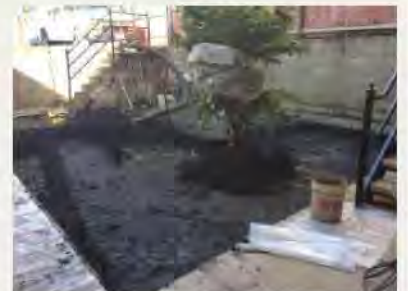
Description: Overview of START conducting XRF screening in the front yard excavation area of Non-Responsive.

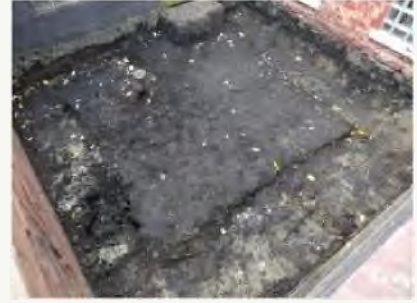
Description: View of the completed backfill with clean soil in the back yard of Non-Responsive.

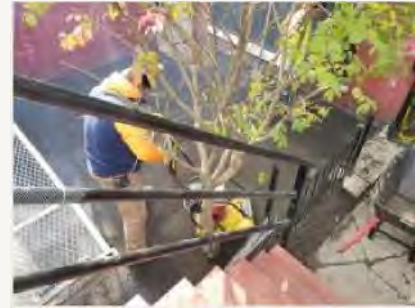
Description: RP contractor placing sod during restoration work in the front yard of **Non-Responsive**.

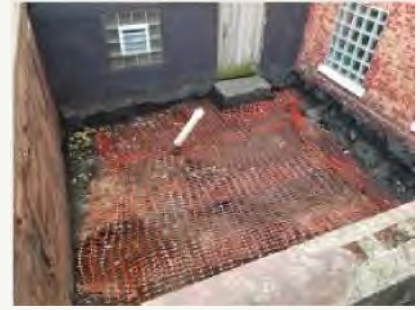
Description: RP contractor backfilling the excavated back yard area of [Non-Responsive] under a deck with gravel.

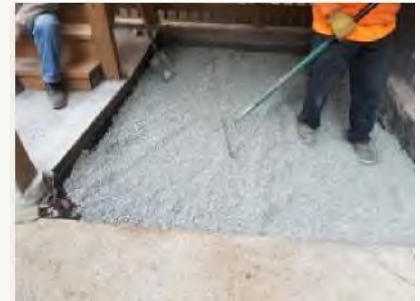
Description: Completed excavation of the back yard garden area of [Non-Responsive]

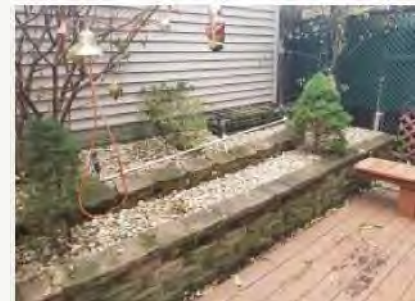
Description: Completed restoration of the back yard garden area of [Non-Responsive]. The area was restored with river rock.

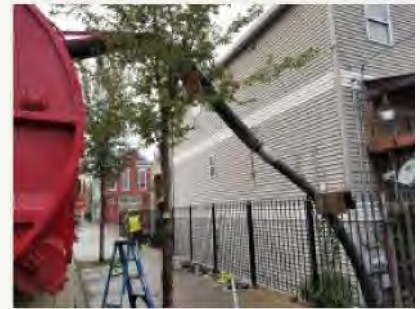
Description: RP contractor utilizing a subcontracted vac truck to collect excavated soil during removal work in the side yard and garden area of **Non-Responsive**. Soil was transferred to the vac truck hose with shovels.

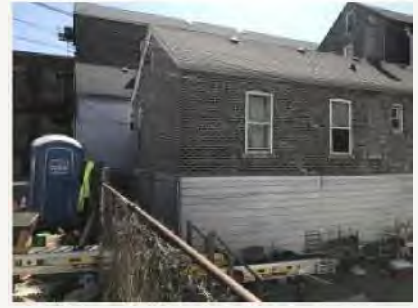
Description: RP contractors grading backfill in the back yard of Non-Responsive .

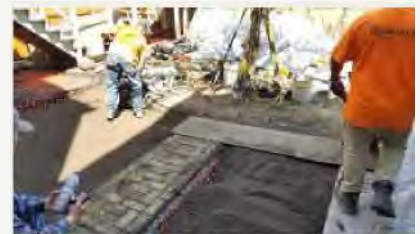
Description: A covered excavated soil stock pile on the north side of the back yard of **Non-Responsive** .

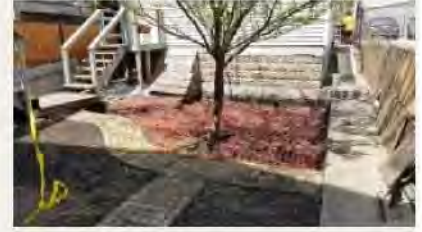
Description: RP contractors compacting backfill in the back yard of a [Non-Responsive] .

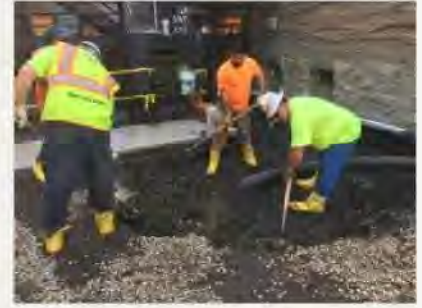
Description: EPA START and GHD collecting confirmatory soil samples in the back yard of Non-Responsive.

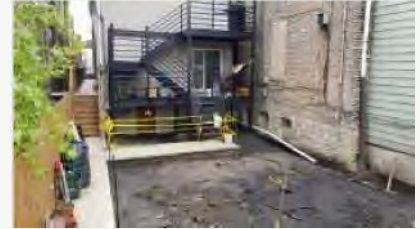
Description: GHD collecting a composite sample for XRF screening in the back yard of a property located at **Non-Responsive**.

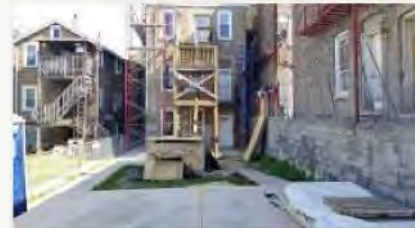
Description: View of the RP contractors conducting utilizing conveyor belts to backfill with gravel in the back yard of **Non-Responsive**.

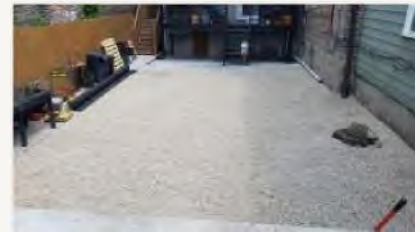
Description: Gravel cover placed in the back yard by RP contractors at **Non-Responsive**.

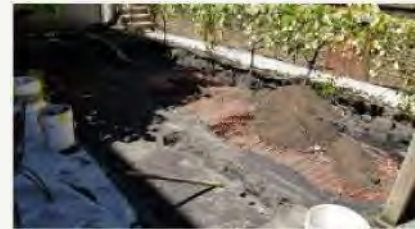
Description: View of the RP contractors backfilling and compacting in the front yard of **Non-Responsive**.

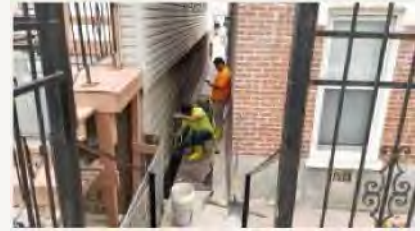
Description: RP contractors excavating in the back yard of **Non-Responsive**.

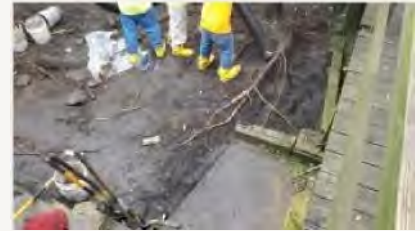
Description: RP contractors backfilling with clean soil in the back yard of **Non-Responsive**. Orange demarcation fence was placed in the bottom of the excavation prior to backfill.

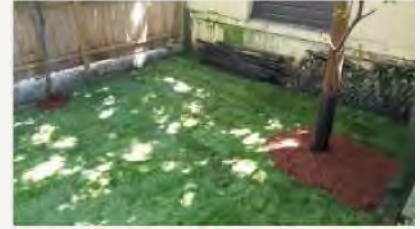
Description: RP contractors beginning excavation work in the back yard portion of **Non-Responsive**.

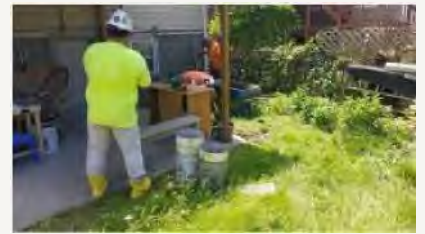
Description: RP contractors continuing excavation work with a vac truck in the back yard portion of the property located at **Non-Responsive**.

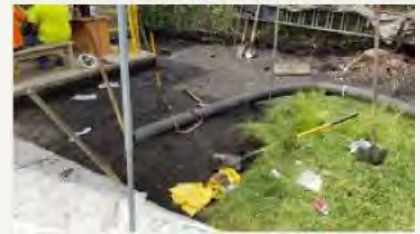
Description: View of completed excavation work in the back yard portion of **Non-Responsive**. Orange demarcation fence was placed at the bottom of the excavation.

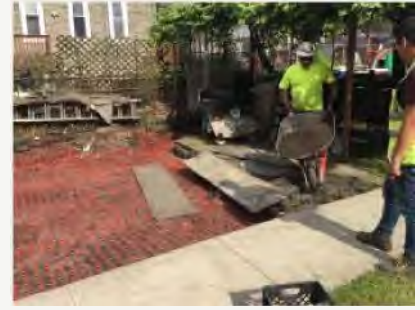
Description: View of on-going backfill work in the back yard portion of Non-Responsive .

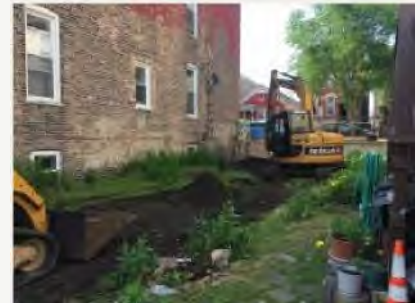
Description: RP contractors continuing to conduct excavation work utilizing an excavator and skid-steer in the open lot portion of a property located at Non-Responsive . As well as the back yard of the adjacent property Non-Responsive .

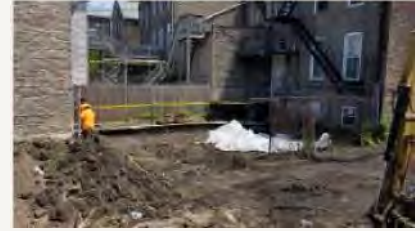
Description: View of orange demarcation fence placed at the bottom of the excavation in the open lot portion of Non-Responsive Non-Responsive.

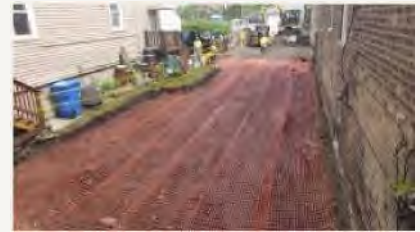
Description: View of orange demarcation fence placed in the back yard of Non-Responsive .

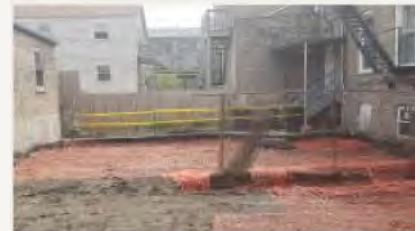
Description: RP contractors beginning to conduct backfill work with clean soil in the open lot portion of Non-Responsive

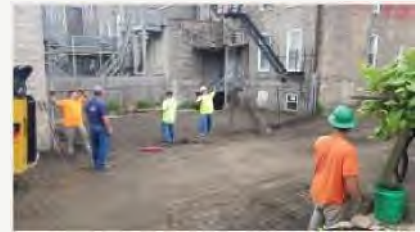
Description: RP contractors placing sod in the open lot portion of **Non-Responsive** .

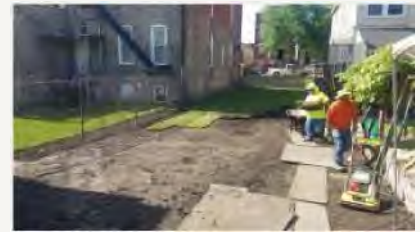
Description: RP contractors conducting excavation work utilizing a vac truck in the back yard of **Non-Responsive**.

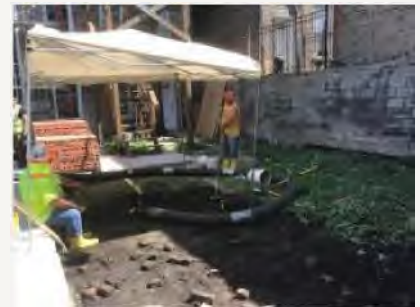
Description: RP contractors placing orange demarcation fence in the bottom of the excavated back yard of **Non-Responsive**.

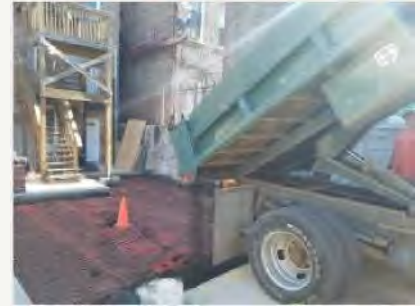
Description: RP contractors compacting backfill soil placed in the back yard of **Non-Responsive**.

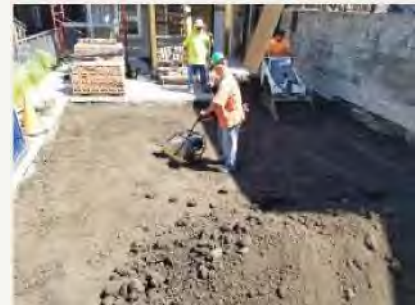
Description: RP contractors utilizing surveying equipment to check the backfill grade in the back yard of **Non-Responsive**.

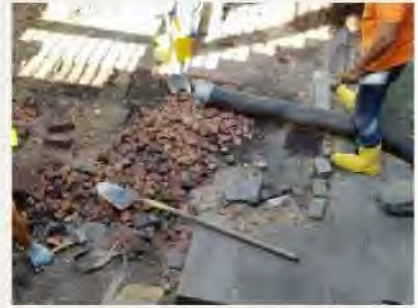
Description: RP contractors conducting removal work in the back yard of **Non-Responsive** utilizing a vac truck.

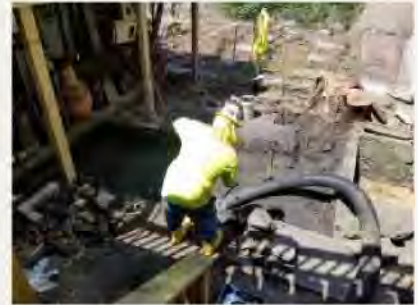
Description: View of orange demarcation fence placed in the bottom of the back yard excavation of **Non-Responsive**.

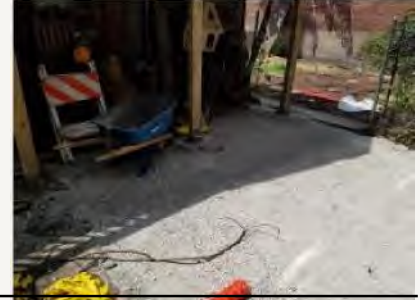
Description: View of the excavated side yard of the of **Non-Responsive**.

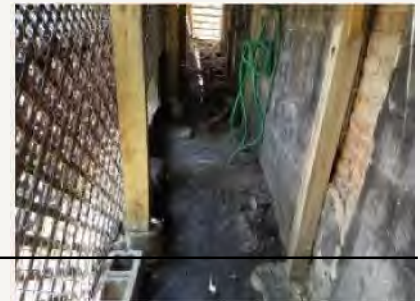
Description: RP contractors beginning to place orange demarcation fence in the bottom of the excavated side yard of **Non-Responsive**.

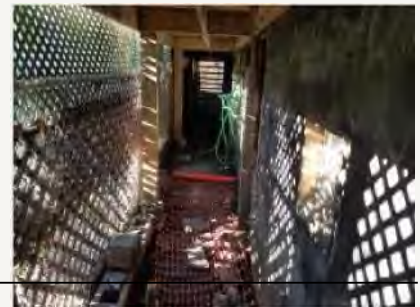
Description: RP contractors utilizing conveyor belts to transfer gravel to the back yard of **Non-Responsive**. Access was through the adjacent property also scheduled for removal work.

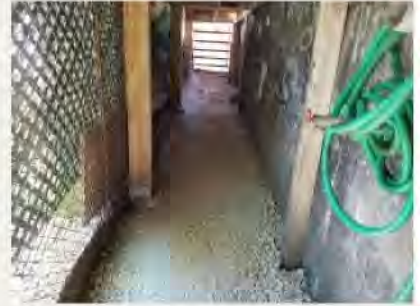
Description: View of construction work in the back yard of **Non-Responsive** for placement of a concrete patio.
